**DEPARTMENT OF TRANSPORTATION**

Contract #: 04-0120F4Cty: SF/ALA Rte: 80 PM: 13.2/13.9File #: 70.28**WELDING INSPECTION REPORT****Resident Engineer:**Pursell, Gary**Address:** 333 Burma Road**City:** Oakland, CA 94607**Report No:** WIR-003586**Date Inspected:** 21-Aug-2008**Project Name:** SAS Superstructure**OSM Arrival Time:** 800**Prime Contractor:** American Bridge/Fluor Enterprises, a JV**OSM Departure Time:** 1630**Contractor:** Japan Steel Works**Location:** Muroran, Japan**CWI Name:** Chung Fu-Kuan**CWI Present:** Yes No**Inspected CWI report:** Yes No N/A**Rod Oven in Use:** Yes No N/A**Electrode to specification:** Yes No N/A**Weld Procedures Followed:** Yes No N/A**Qualified Welders:** Yes No N/A**Verified Joint Fit-up:** Yes No N/A**Approved Drawings:** Yes No N/A**Approved WPS:** Yes No N/A**Delayed / Cancelled:** Yes No N/A**Bridge No:** 34-0006**Component:** Tower, Deviation and Jacking Saddles**Summary of Items Observed:**

## WELDING INSPECTION REPORT

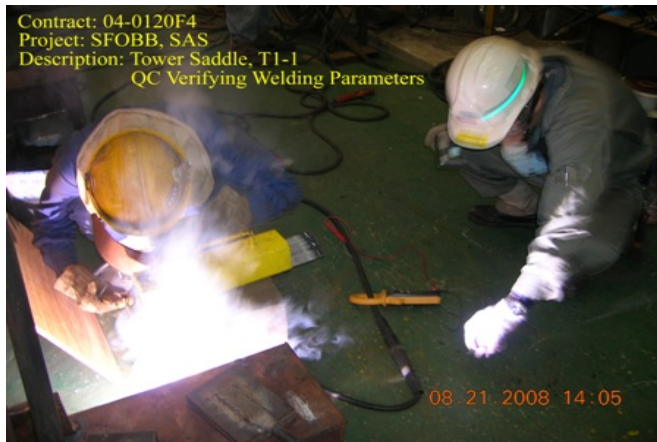
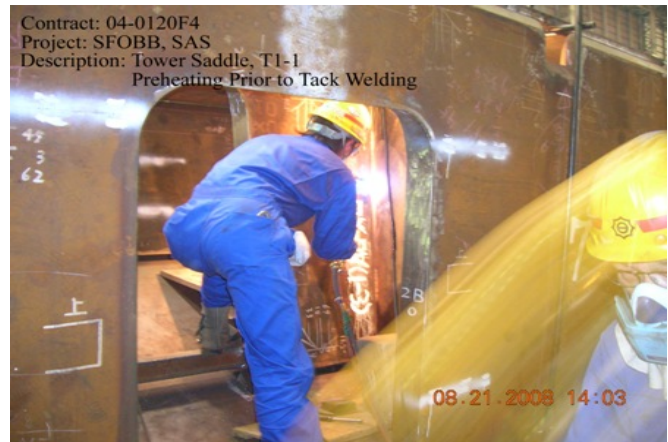
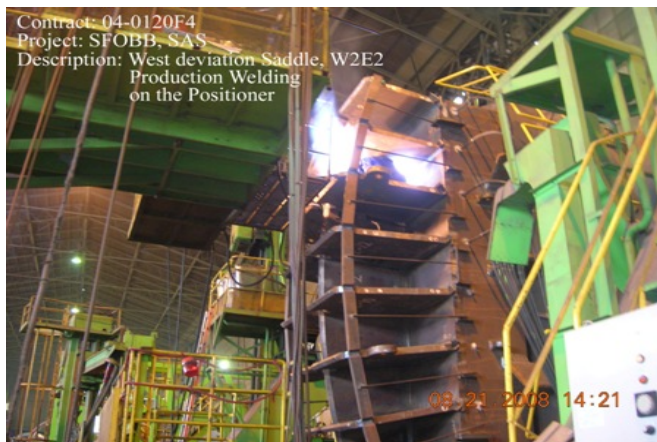
Later in the shift at approximately 1030 hours, the QA inspector traveled to the Fabrication Shop # 4 to observe the shop welding, weld inspection and verification of the welding parameters on the structural steel plate components for the West Deviation Saddle identified as W2E2. The Welding was performed by the JSW welding

The QA inspector observed the removal of four (4) cracked tack welds on the T1-1 Tower Saddle located at the rib to stem plate connection identified as 7Y-7V (1-3) and 7Y-7V (1-2). The removal of the tack welds was performed by JSW welding personnel Mamoru Kubota ID 74-3666 utilizing the manual air carbon arc cutting process and the cut surface was finished by grinding to a bright metal. At the conclusion of the removal of the cracked tacks Nikki Inspection Service (NIS) QC/NDT personnel, Kazuya Kobayashi performed a Magnetic Particle Test (MPT) of the areas utilizing an AC Yoke, Type A-6 testing unit which appeared to be manufactured by Eishin Kagaku Co., Ltd. The MPT was performed on 100% of the repaired areas and was conducted utilizing the MPT procedure identified as SF-MT-01.

On this page of this report, see Weld Joints in Progress Inspected regarding the QA observations of the production welding parameters recorded and the digital photographs which illustrates the observations of the activities performed on this date.

At the conclusion of the testing the welders Mamoru Kubota ID 74-3666 and Tatsuya Naitoh ID 71-2736 performed the tack welding utilizing the Shielded Metal Arc Welding (SMAW) process as per the Welding Procedure Specification (WPS) identified as SJ-3012-2. The QC inspector monitored the welding and verified the welding parameters which appeared to comply with the contract documents.
